Technical Paper on

OOPS TESTING OF TILT-UP TOP PLATE CONNECTIONS

By Eugene Trahern, PE¹, Stuart Carter, PE², Richard Adatto³

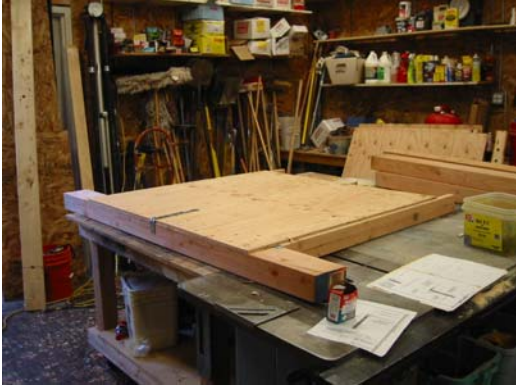
Construction of Test Panel
Photograph 1

Six wood-framed test panels were fabricated based on construction documents for a tilt-up structure built in 1988. The building utilizes ½” plywood sheathing on 2x4 subpurlins located at 2’-0 on center, which in turn are supported by 4x14 purlins located at 8’-0 on center. The roof diaphragm is supported at the perimeter of the building by metal hangars connected to a 4x top plate which is bolted to the 5½” thick concrete wall with ¾” anchor bolts spaced at 4’-0 on center. Out-of-plane anchorage is provided by Simpson ST6224 straps located over each purlin at 8’-0 on-center and ST12 straps located over subpurlins at 4’-0 on-center (Photos 1, 2).

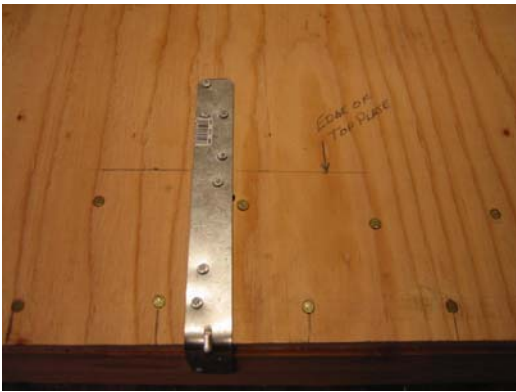
ST12 Strap Installation
Photograph 2

1. The length of the ST12 strap is such, that when installed per the construction details, only 4 nails were provided into the subpurlins. (Photo 2)
2. The ST12 strap provided little additional strength to the overall connection. While test panel 3 indicated the strap provided 2,900 lbs to the connection, test panel 3A (without any strap) had an ultimate load similar to test panels 1 & 2 (7,000+ lb). Therefore, the primary out-of-plane load transfer is provided through nailing of the plywood to the top plate (cross grain). (Photo 5).

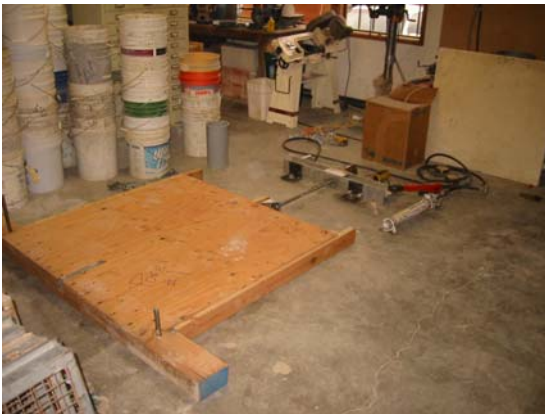
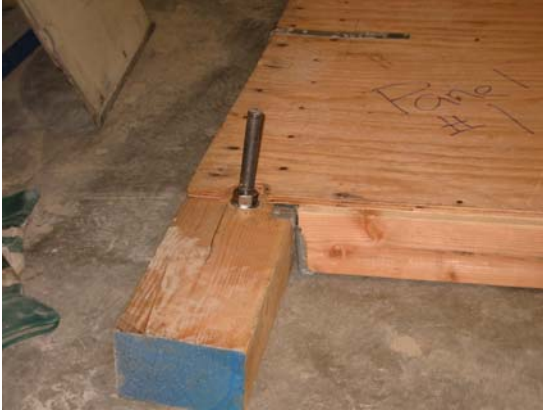
Test Panel Setup
Photograph 3

Test Panel Setup
Photograph 4

Testing of the tilt-up panels was performed by Mayes Testing Engineers in Everett, WA on December 19, 2002. Test panels were laid flat on a concrete floor slab and bolted into the slab with ¾” anchor bolts at 4’-0 on center in order to replicate the connection of the

top plate to the top of the concrete wall. Monotonic testing was performed using a 20 ton hydraulic ram with a 2 ksi gauge for Panels 1-3 (ST12 straps) and a 20 ton ram with a 5 ksi gauge for Panels 4-6 (ST6224 straps). Gauge readings were in psi, then converted to kips using calibration curves. (Photos 3, 4)

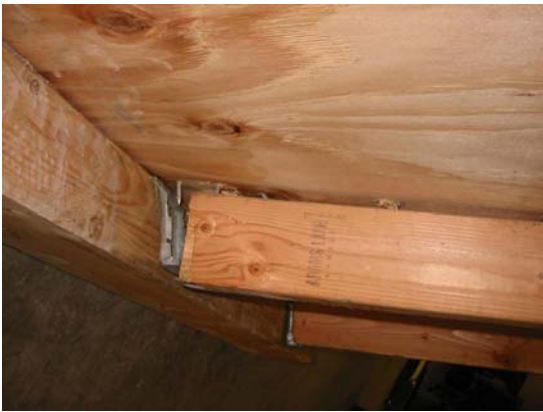
Separation of Strap from 2x4 Subpurlin
Photograph 5

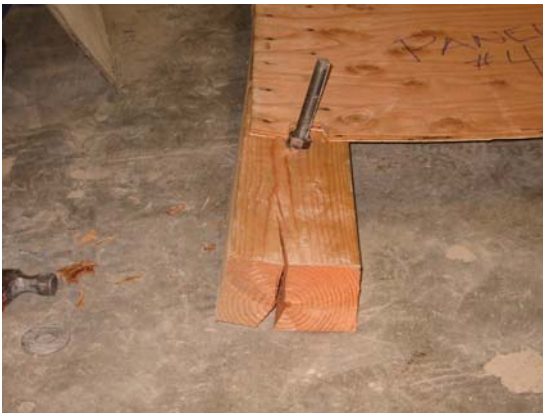
Cross Grain Bending of Top Plate
Photograph 6

3. The ST6224 strap in panels 4-6 contained enough strength that the top plate failed. The wrap around design resulted in cross grain bending of the top plate. (Photo 6)
